BUILDING-STRUCTURE INVENTORY FORM

- 1. BUILDING NAME(S): _____
- 2. COUNTY: Erie TOWN/CITY: Buffalo VILLAGE: _____
- 3. STREET LOCATION: 684 Crescent Ave
- 4. OWNERSHIP: a. public b. private
- 5. PRESENT OWNER: Emma Gamble ADDRESS: 684 Crescent
- 6. USE: Original: Residential Present: Residential
- 7. ACCESSIBILITY TO PUBLIC: Exterior visible from public road: Yes No
Interior accessible: Explain by permission

19. DATE OF INITIAL CONSTRUCTION: 1922

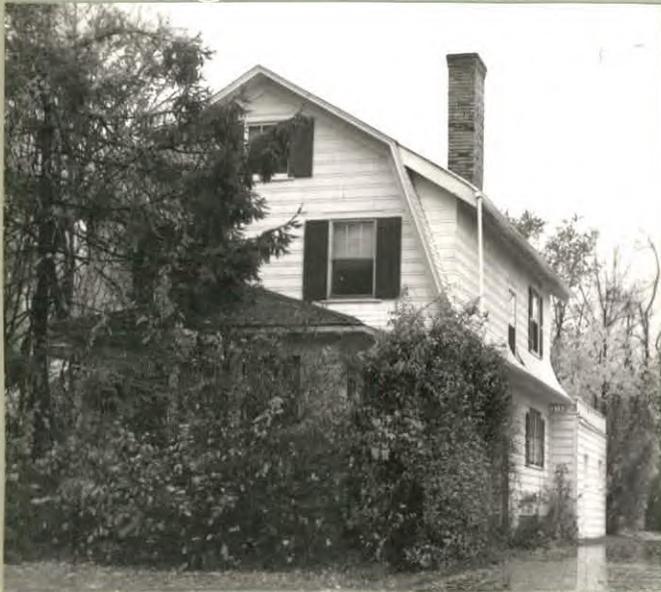
12. PHOTO: 3-7a & 19-16a

18. OTHER NOTABLE FEATURES OF BUILDING AND SITE (including interior features if known):
 Two story Dutch Colonial Revival style. Front facing gambrel roof. Hip roof first floor wing. Has 6/1 windows. Second floor 6/1 windows. Window shutters. Gable has 6/1 window with shutters. Shed roof dormers with exposed rafter tails under eave.
